## **Study and Analysis on the Instability Of Galati Town at Danube Cliff Area**

**Stefan Dragomir<sup>1</sup>, Georgeta Dragomir<sup>2</sup>**

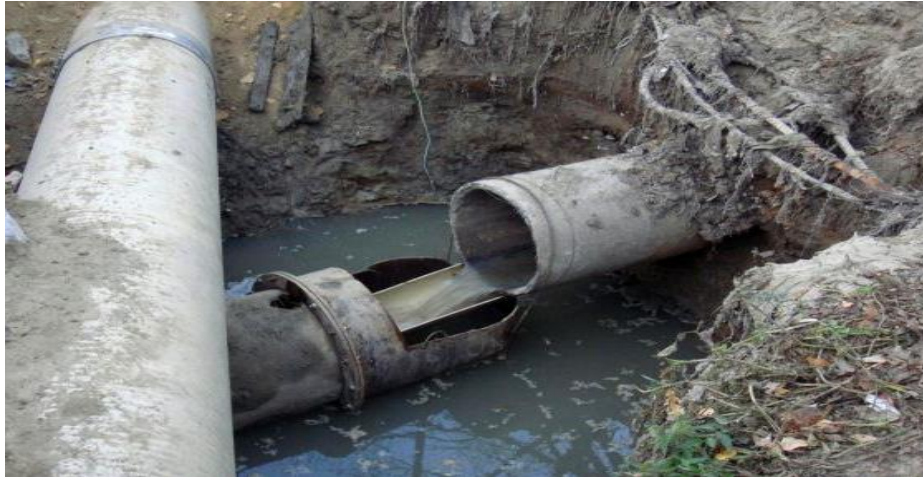
Works which have been carried out aimed to find the cause of the affected of the old sewerage collector that have more than a hundred years. The waters of this manifold pressure in the land in the area have led to the first subsidence of the road (figure 1).

The conclusions of the study were that surparea highway was caused by several causes: partial wetting of the land in the area, with water infiltrated rainfall, the missing of land sistematisation on the vertical and possible loss of water from the sewerage networks in the area. The process of infiltration of the waters in the field was favored because of the existence in the area of unomgeneous soil filling.

As a result of these causes, the land has been the subject of additional settlements when dried and implicitly to the appearance of “the phenomenon of soil collapse”.

**Figure 1. The sewerage collector from the “Propeller area”<sup>1</sup>**

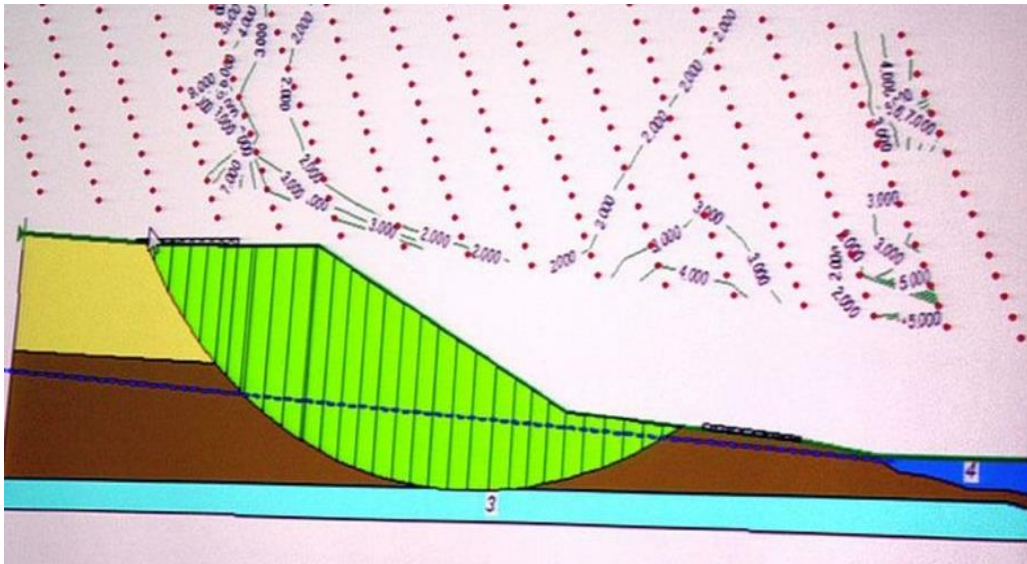
In this area of the top of the cliff i.e. toward the south of the botanical garden the situation has worsened from the expertise in 2012 at the 2014. In this area have brought large quantities of material of the stuffing (sagging incorrect) to bring it to the dimension of achieving portion of the Great Union There (figure 2). With the green color is represented the material of the stuffing added in the '60. Yellow and brown represents the old ground over which was added the material to the filling. The color of the light blue represents the groundwater and The Blue Danube.

Under the influence of the groundwater, which was raised from 40 to approximately 15 meters, in the loess laier have formed numerous caves and settlements which endanger the safety of the buildings in the area. Slip the material of the filling is added 8-12 millimeters per year.

**Figure 2.** The diagram in the technical study, which shows the subsidence<sup>1</sup>

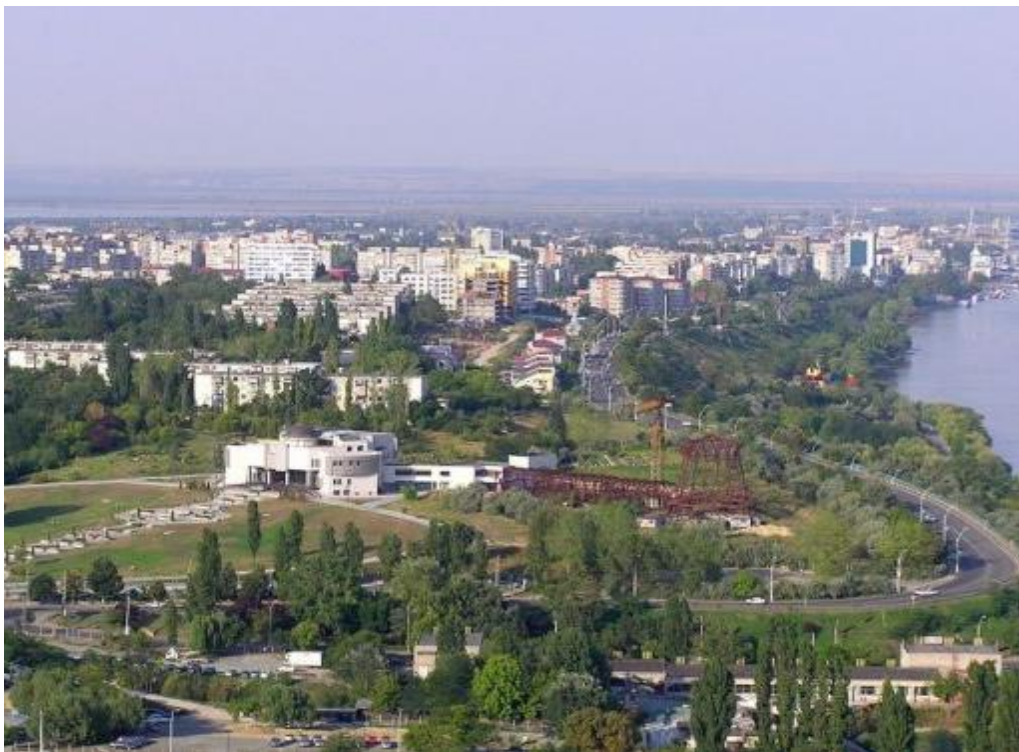
This region have the most sensitive risk imminent danger of collapse for the road curve of the cliff (that piedmont has already damage: asphalt wrinkled and visible cracked due the jarring induced by the lorries and trucks of more than 5 tonnes, then when climbing or lower it to embark.

From measurements on which we made them and on a path of the coast of the curve in the hairs are already visible cracks in the asphalt, which means that the movements are produced continuous. As regards the movements of land recorded, the most disadvantageous situation is in the south of the Garden. The movement in this area is a shear bolt, area of disposal is at approx. 30 meters depth and shifts are 3 cm in a month having regard as the direction toward the ferryboat.

**Figure 3. The area “Curve to the ferryboat”<sup>1]</sup>**

It is necessary to prohibit the heavy between 5 and 100 tonnes (lorries and dumpers) loaded with calacar which in their movement induces in the area of the tank, microseisme approximately 3.5 degrees Richter. In that area the movements and cracks on the corresponding piedmont “avenue the Great Union” - namely the southern part of the Garden. It is recommended to complete shutdown of the movement of heavy vehicles on the avenue of “the Great Union” and area ferryboat to avoid the curve damage.

Shall be prohibited to carry heavy (Lorries over 5t) because determine a lot of jarring in the area of the ferryboat and its routing must construct outside of the Galati city.
